Jet grouting

LA DUCHÈRE TUNNEL LYONS NORTHERN RING ROAD

Consolidating a collapsed tunnel via compaction grouting from the surface and horizontal jet grouting while progressing

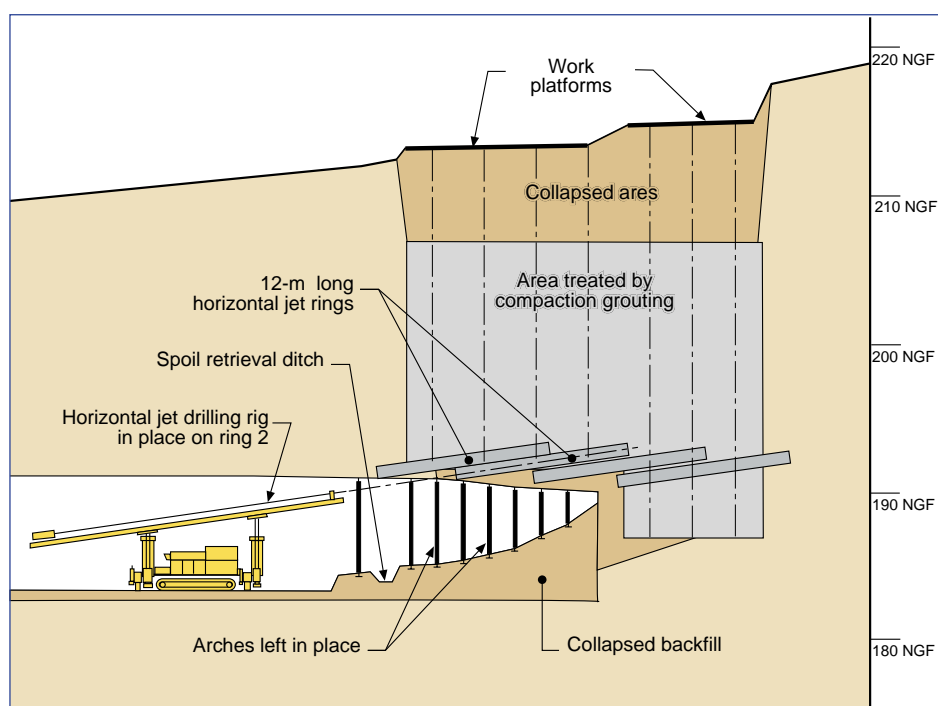
At the western end of the South pipe nearest the hillside, because of extremely weathered ground covered by 15 to 20 m of clayey-sandy colluvium, the screw and discharged concrete support structure was reinforced by arches every 1.5 m. However, at PM 201, the tunnel face crumbled and collapsed soil resurfaced, thus creating a 15 to 20 m-diameter and 4 to 5 m deep depression.

Longitudinal section showing treatment by compaction grouting and horizontal jet

- reconsolidating collapsed ground from the surface via the compaction grouting method, with a drill mesh of about 3 x 3 m.

- building an umbrella vault while moving forward from the tunnel, using 4 slightly divergent (about 11°) concentric rings of 12 m-long jet grouting columns, reinforced by 89 mm-diameter and 12.5 mm-thick pipes. In each conical ring, the columns are spaced out every 0.75 m (for an 80 cm-diameter in collapsed parts) and cones fit together in order to ensure permanent dual protection of superposed columns.

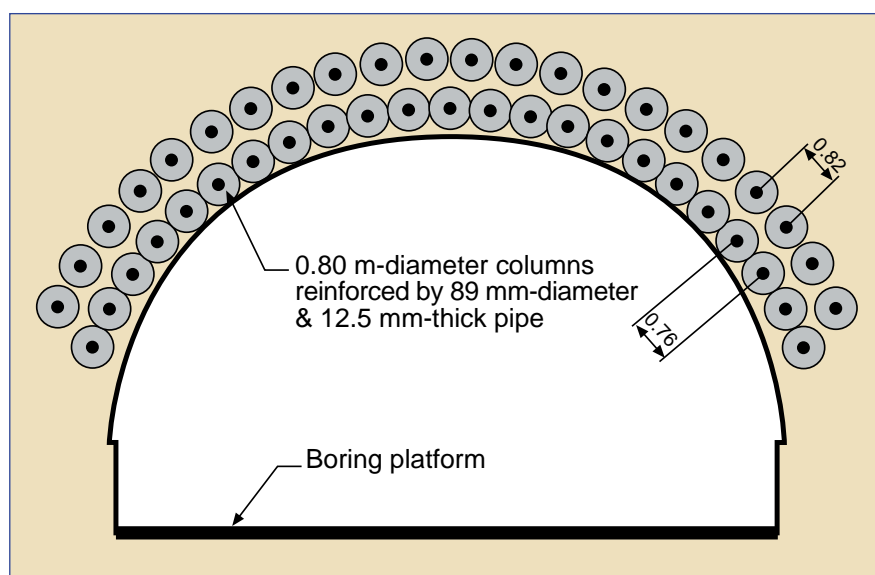
Standard cross-section of jet treatment
