# Compaction grouting

## CONDAMINE BREAKWATER MONACO

### Consolidation of foundation soil under caisson

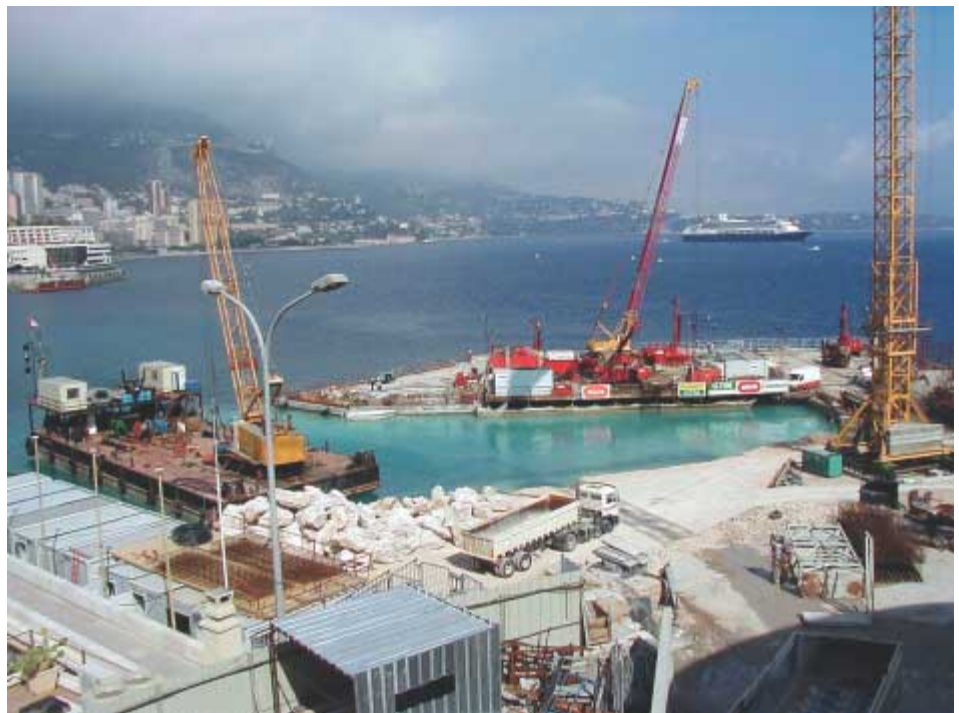
View of jobsite

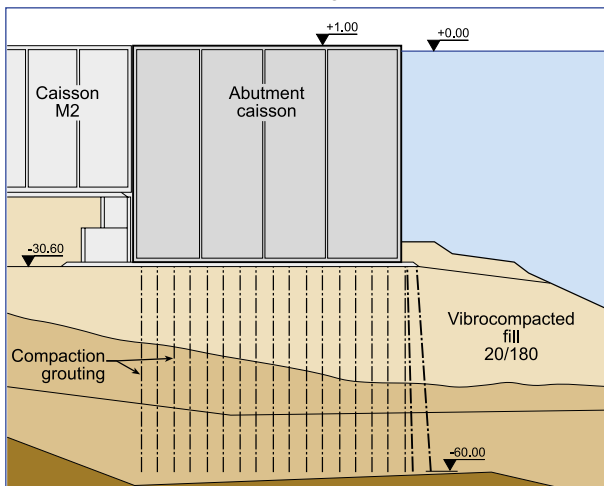
Typical cross section

The treatment concerned an area measuring 80 x 40m and a thickness of 25 - 30m of ground under the caisson. The ground was investigated by drilling, coring and pressuremeter testing. The grouting holes were drilled in a 3.40m square array for the primaries and secondaries and a 2.40m square array for the tertiaries where the in place material had not been removed.

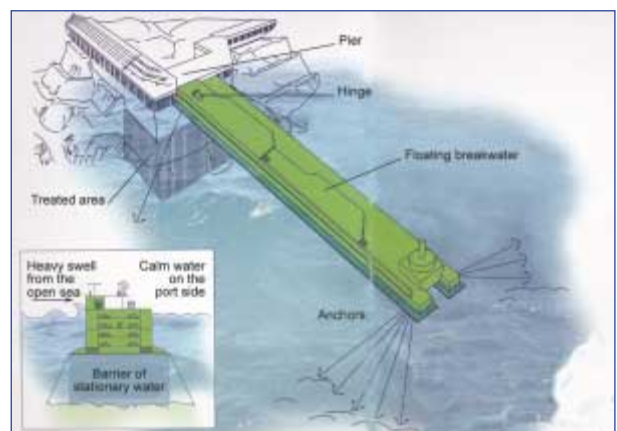
Floating breakwater and abutment pier
