# Jet grouting

## RER C - ST BERNARD TRENCH (REGIONAL SUBURBAN UNDERGROUND NETWORK) QUAI D'AUSTERLITZ - PARIS - FRANCE

### Consolidating an existing structure with Jet grouting columns

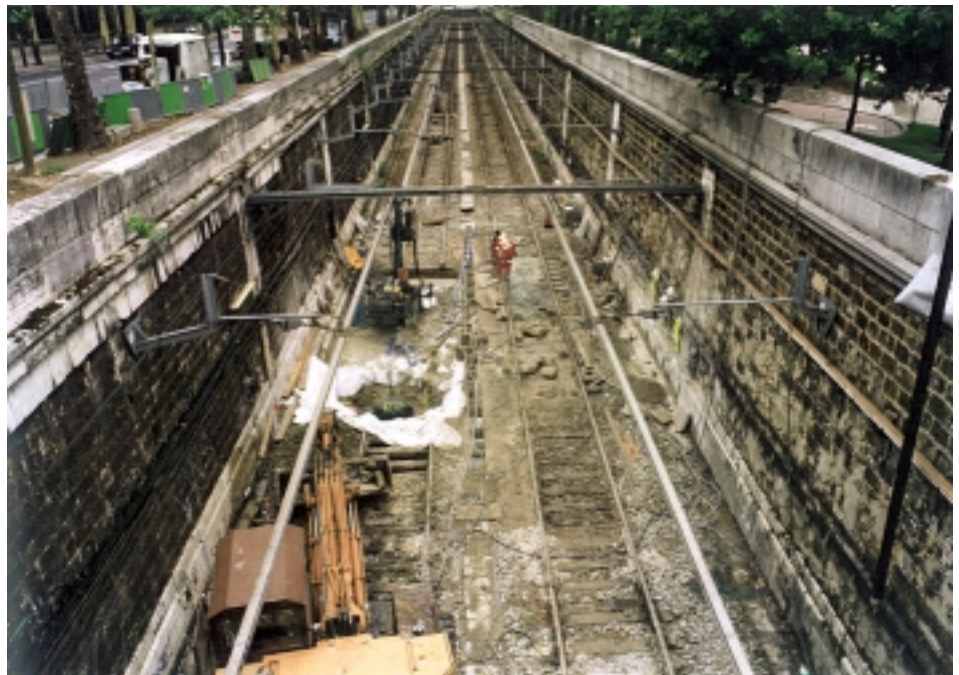
Overview of survey phase

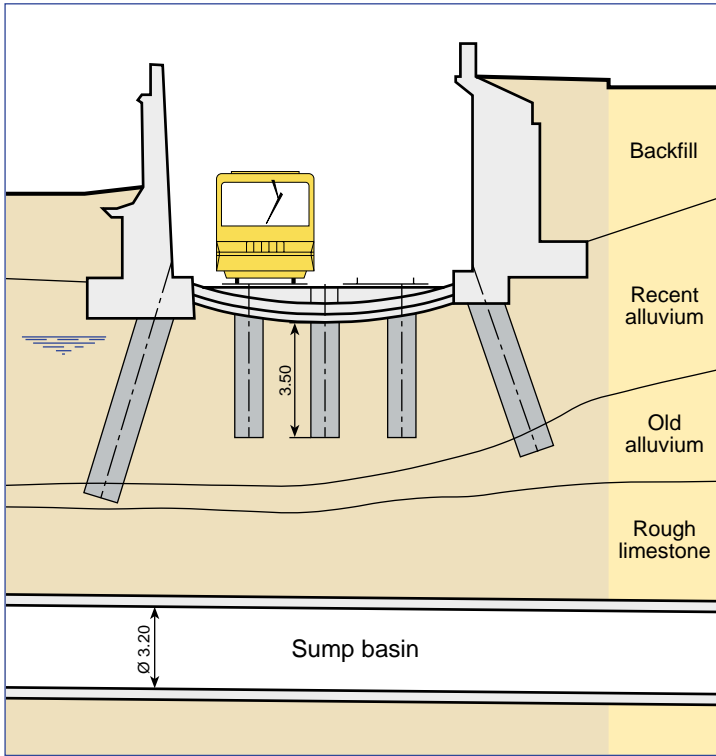
Standard treatment section

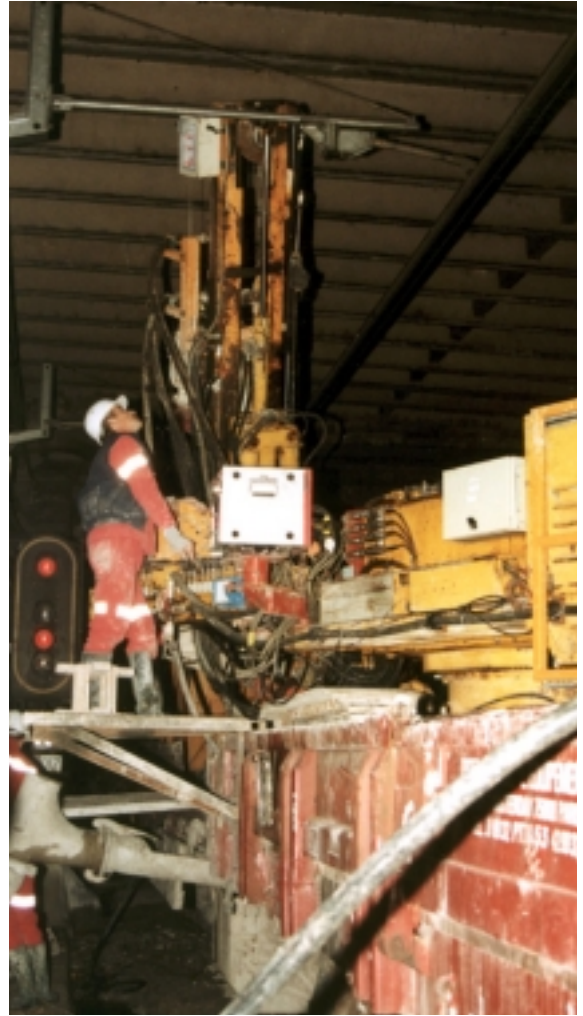
Producing columns within tunnel area from a works train

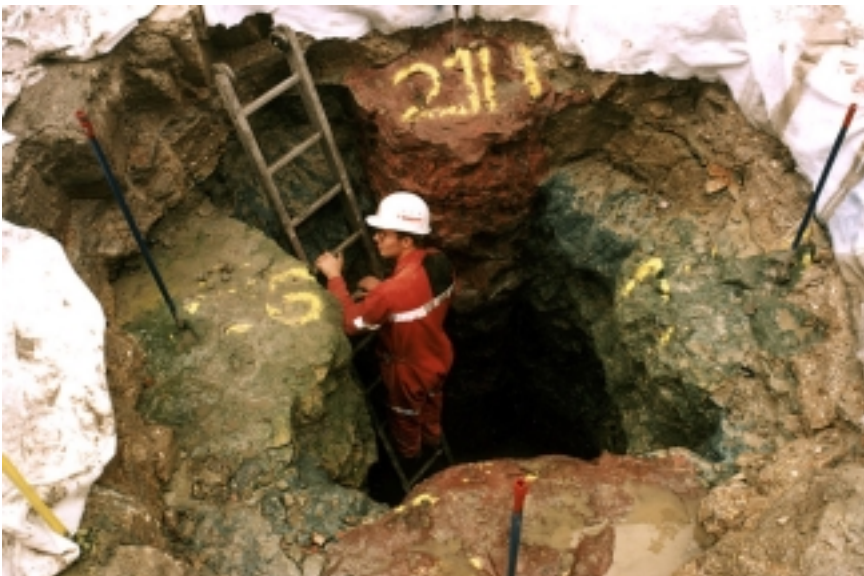
Test columns

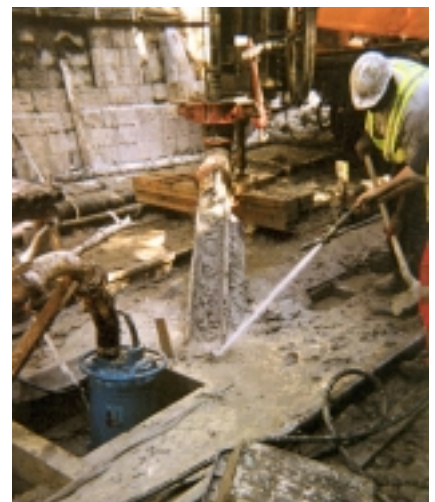
Double jet column during execution
