Grout curtain cut-off and drainage

TURKWEL DAM

WEST POKOT DISTRICT - KENYA

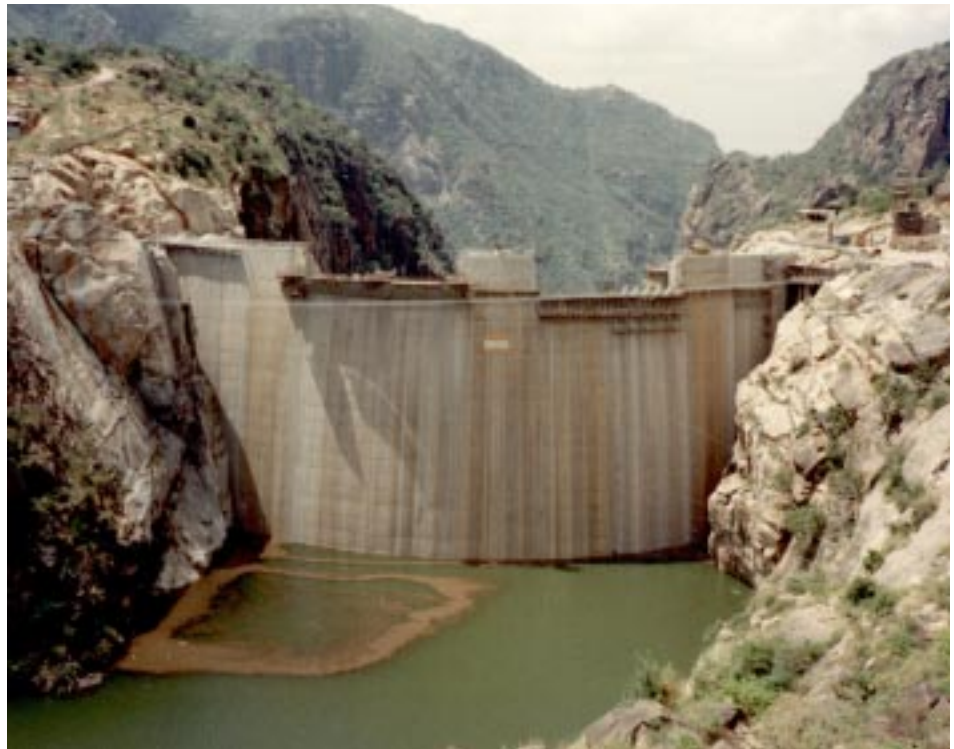
The completed dam

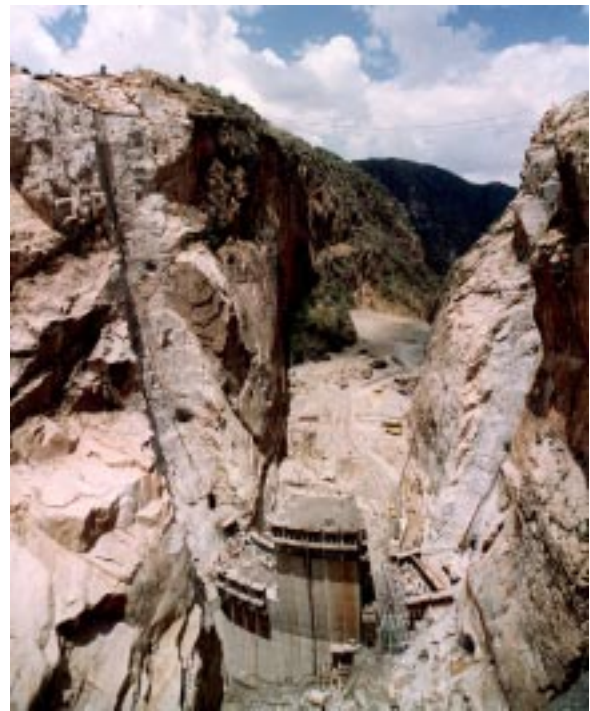
The gorge after excavation to foundation level
