Remediation

CLIPPER OIL

LLICA DE VALL - CATALONIA - SPAIN

Construction of an active barrier with Drain Panel® gates at a site contaminated with hydrocarbons and derived products

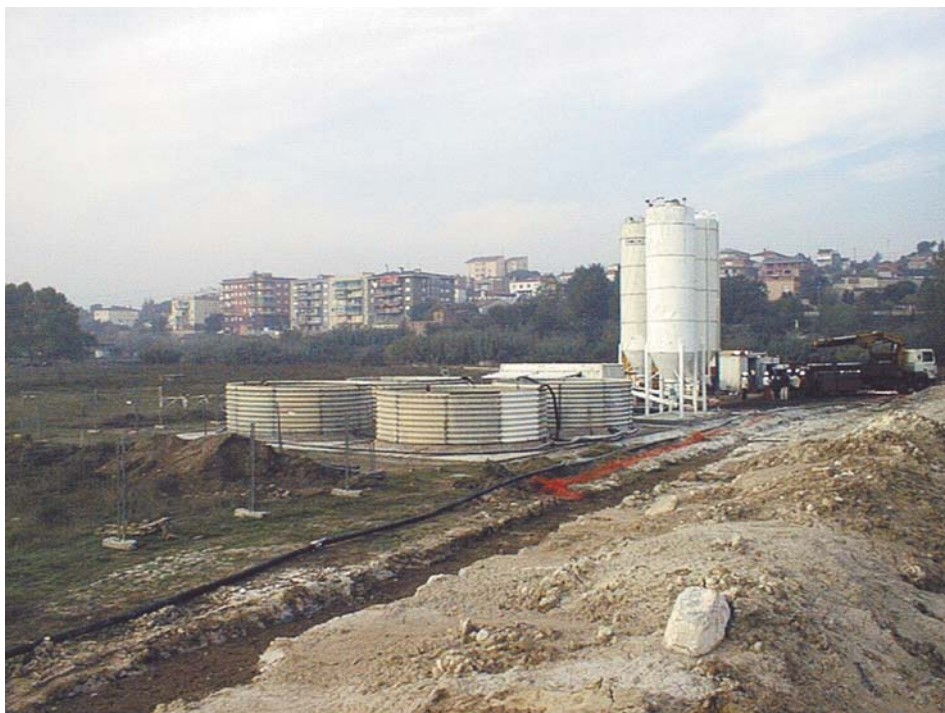
View of site during construction

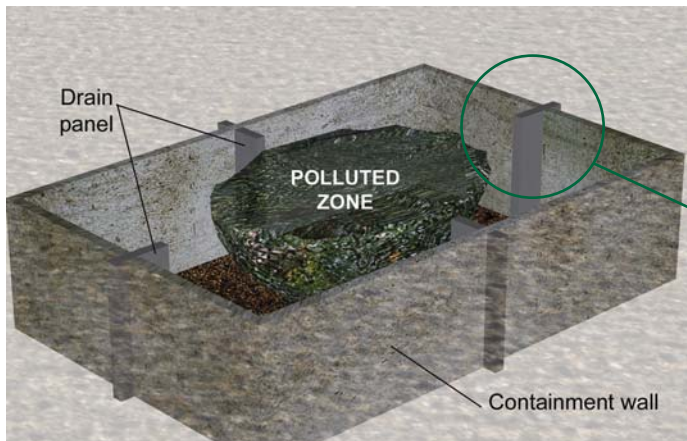
▲ Basic active barrier principle

The active barrier operates on a simple principle. The enclosure is open at the top and when it rains, the water escapes through the Drain Panel® gates which have filters to trap the pollutants coming from the natural leaching process or disturbed by excavation of contaminated soil.

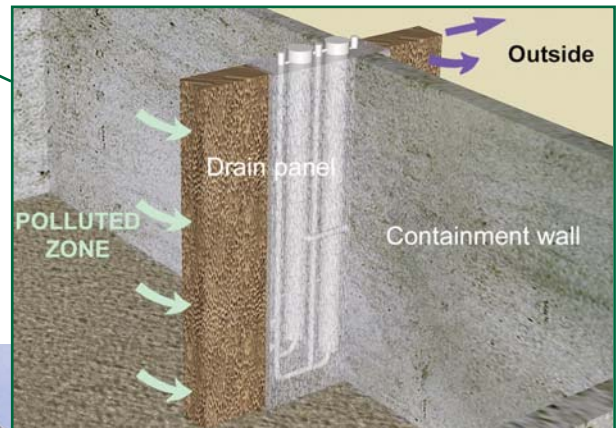
View of a filter gate ➤

- Surrounding slurry trench wall, 5.2m deep, dug with a long-reach backhoe. Wall permeability was less than 5×10^{-9} m/s.
- Two filter gates built with patented Drain Panel® technology in which filters trap organic contaminants such as heavy hydrocarbons, PAHs, PCBs and phthalates. The gates can operate either in series or in parallel.

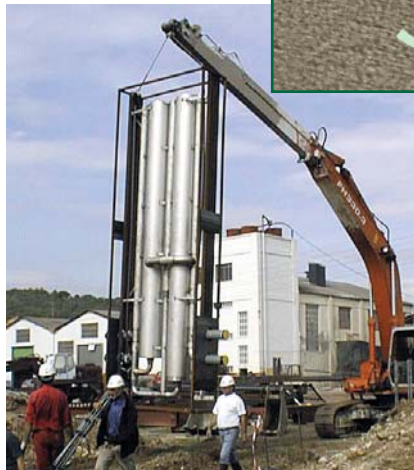
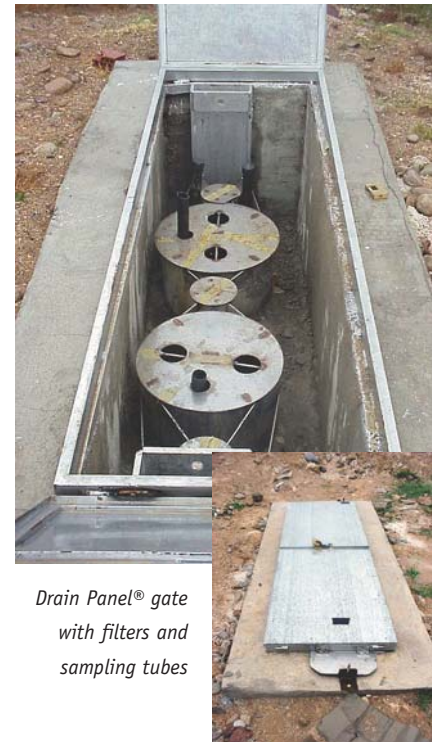
Drain Panel® gate with filters and sampling tubes

The gate filters are:

- designed to be replaced yearly on the basis of the foreseeably slow flow rate in this Mediterranean climate and the high degree of pollution,
 - fitted with sampling tubes to test the filter medium for saturation.
- Gate inflow and outflow analysis revealed better than 90% reduction in dissolved hydrocarbons.

All parts of the gate are readily accessible for cleaning, which simplifies maintenance.
