Reinforcement of banks

Vibwall (thin slurry wall)

LENS CANAL EMBANKMENTS

LOISON-SOUS-LENS - PAS-DE-CALAIS - FRANCE

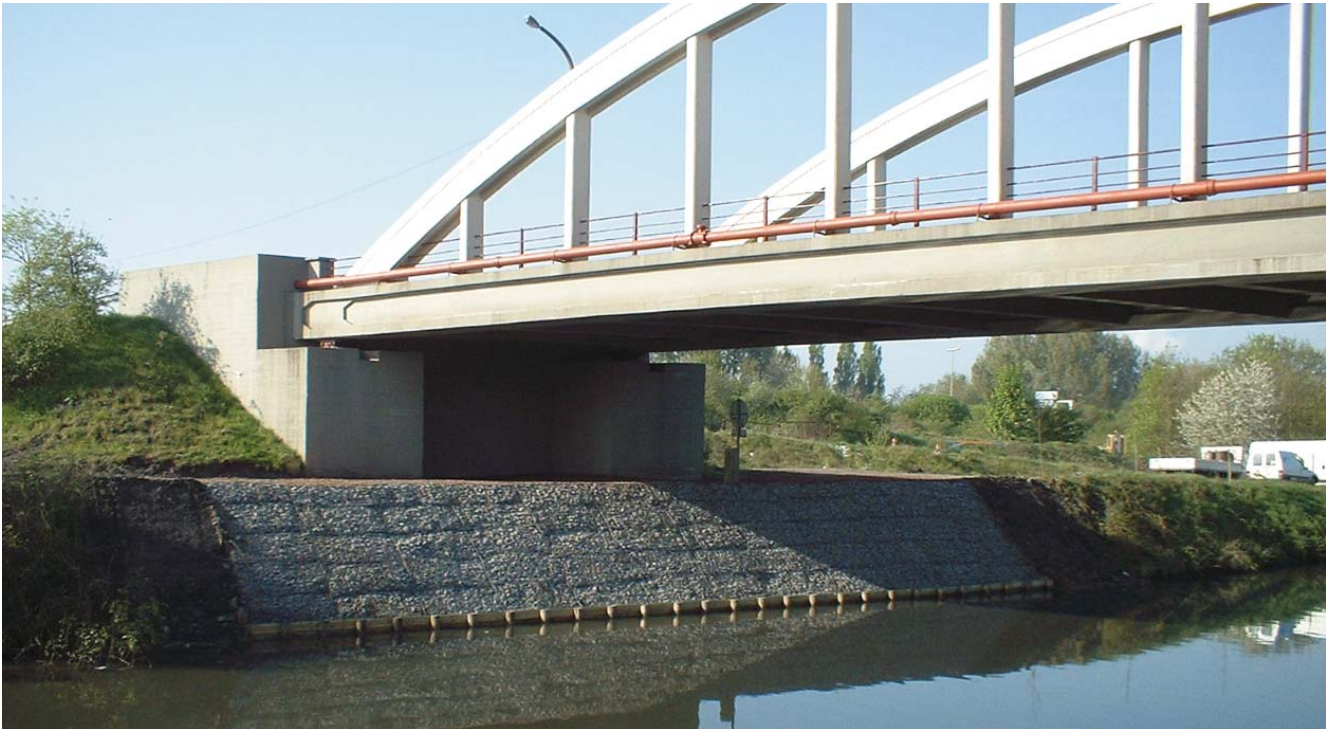
Vibwall (thin slurry wall) cut-off to reinforce the Lens Canal Embankments

The works consisted of the construction of a thin slurry wall along a section nearly 2.4km long.

- stop seepage into the embankments so as to protect them from internal erosion problems and reduce flow into the ground water table of the earth below.
- reinforce the embankments so as to prevent surface landslip.

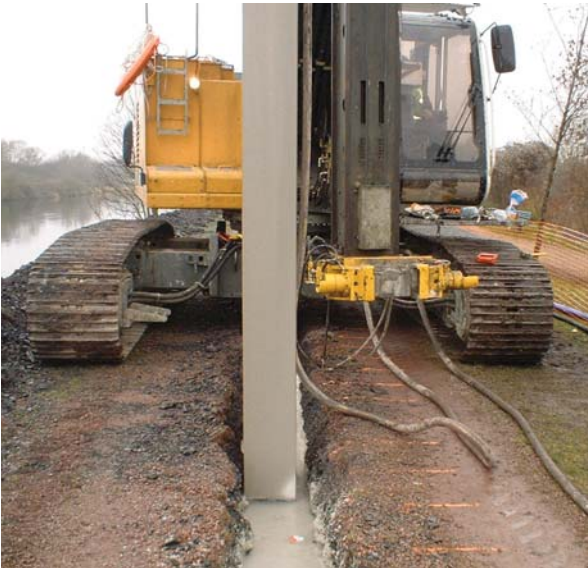
Construction of a thin cut-off wall by vibwall technique

- Construction of a vibwall cut-off:
 - Thickness: 6cm - Total length: 2,395m
 - Depth: 5 to 8m - Corresponding to a total of 15,765m²
- Protection of the banks under a bridge with wattle-work and wood (52m) and flat gabions (260m²).
- Bypass using sheet-piling and restoration of two discharge structures.
- Removal and reinstallation of street furniture, cutting down and planting of shrubs and bedding plants, river signals, maintenance of access for walkers.
- Reconstruction of towpaths.

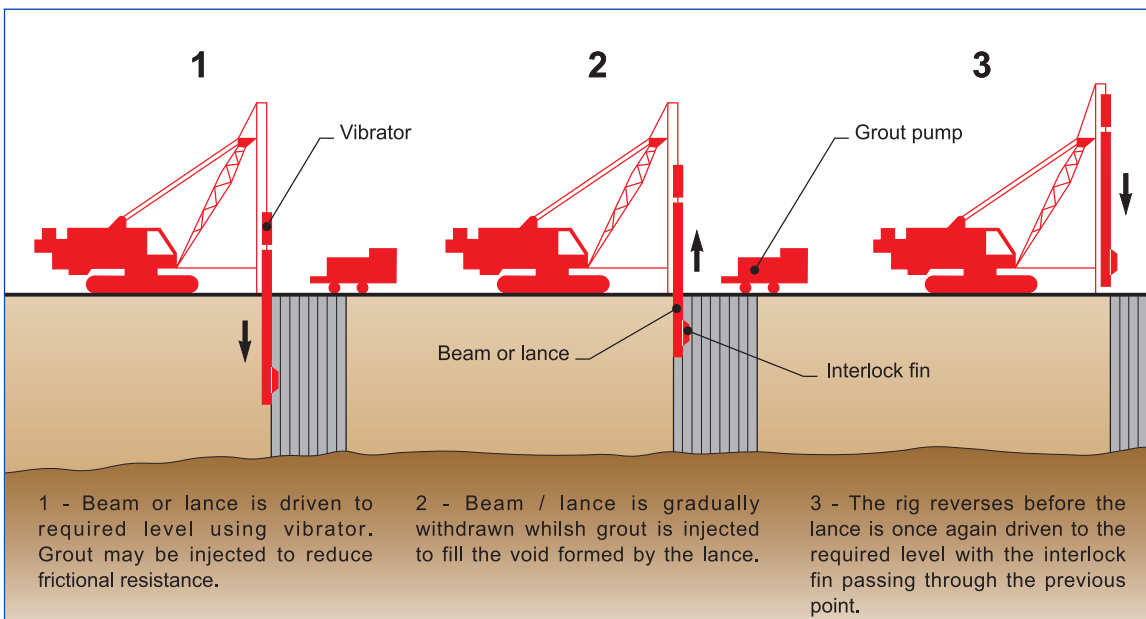
Vibwall installation sequence
